Design Guidelines for the City of Blanco, Texas

Mainstreet Architects Inc.
133 West Mislettee
San Antonio, Texas 78212

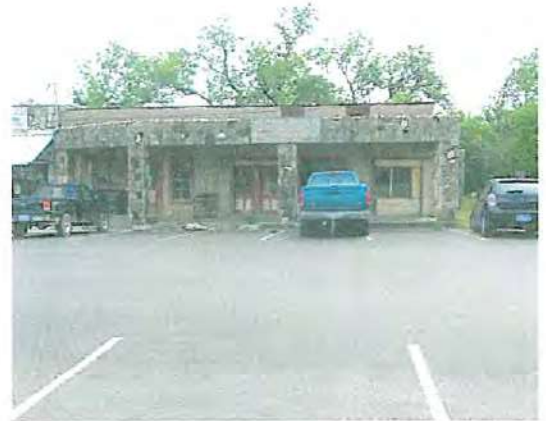
The overall condition of the building should be evaluated to determine repair and maintenance priority.

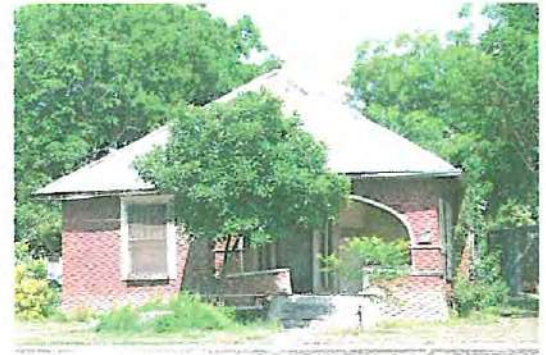
Addressing issues that will prolong the life of the building should be attended to first.

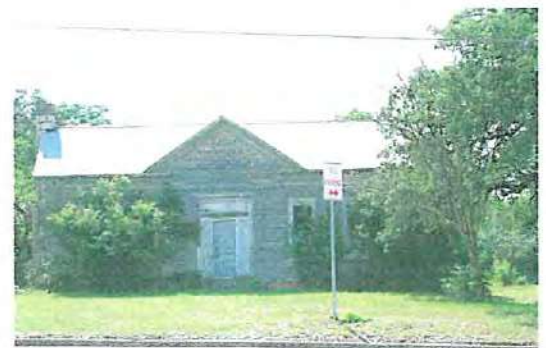
When replacing historic features that are beyond repair, the replacement should be of the same material and dimension of the original.

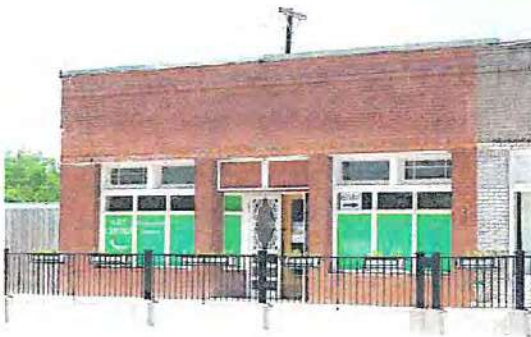
Parapets should have a sound "cap" to prolong the life of the roofline material.

- c. Regularly inspect the roof for leaks and patch them immediately. Leaks commonly occur where the roof and wall meet and where roof penetrations are present. Commercial buildings often have a parapet that should have a sound "cap."

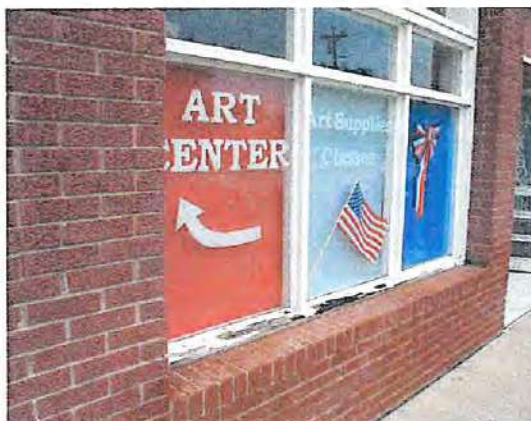
Historic wood windows should be inspected and maintained on a regular cycle to prevent deterioration as seen above.

- e. Regularly inspect the windows and conduct cyclical maintenance. Historic wood windows were constructed so the damaged wood elements can be repaired without requiring that the entire window be replaced.

- f. Damaged wood components should be repaired or replaced as appropriate. Any damaged or missing glazing putty should be replaced, and the window should be painted to ensure long term preservation.

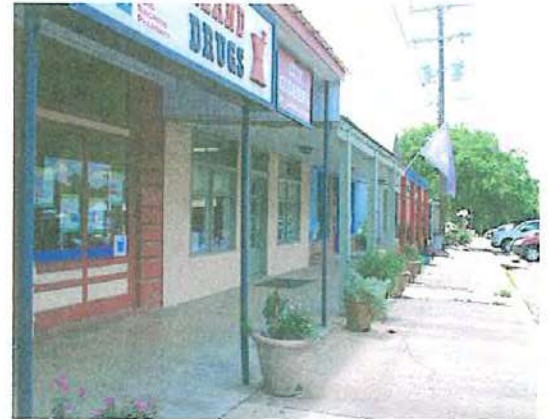
Canopies along with their attachments, anchors, and structure should be regularly inspected.

- g. Regularly inspect canopy and awning attachments, anchors, and structure. Replace worn or damaged materials when necessary.
- h. Repaint wood and metal building components to protect them from deterioration.
- i. Keep signs freshly painted and securely anchored on commercial buildings.

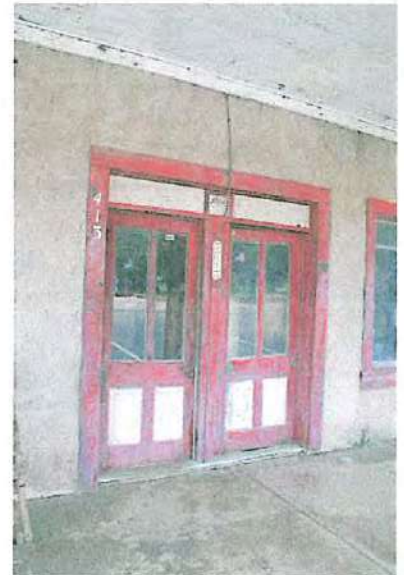
Wood and metal building components should be maintained with paint to protect it from deterioration.

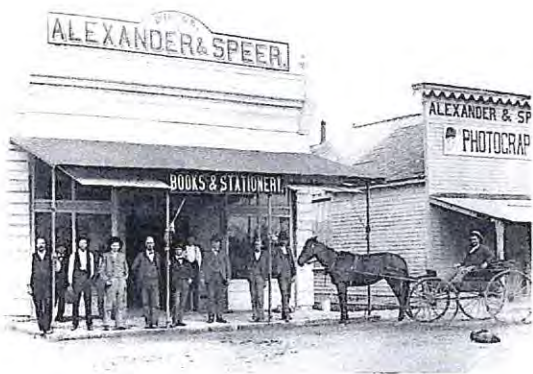
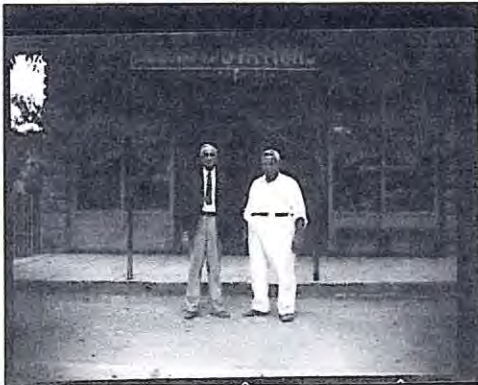
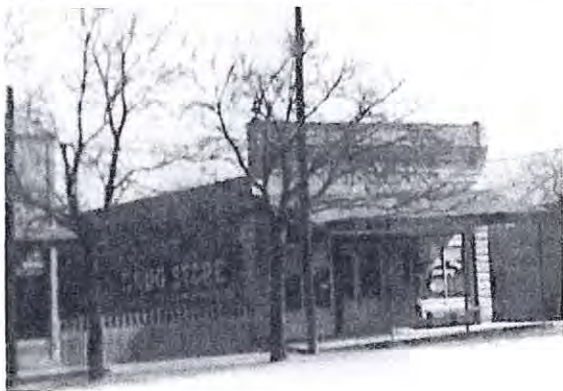
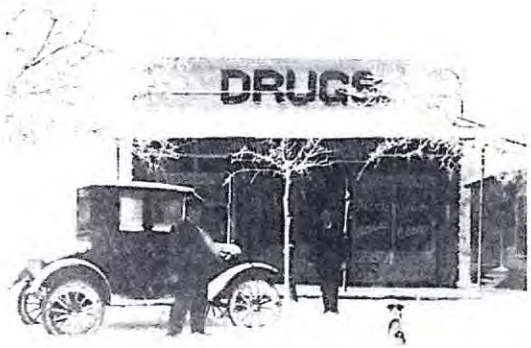
The evolution of the historic drug store in Blanco can be seen through historic photographs. The original design can be restored with the aid of photographic documentation.

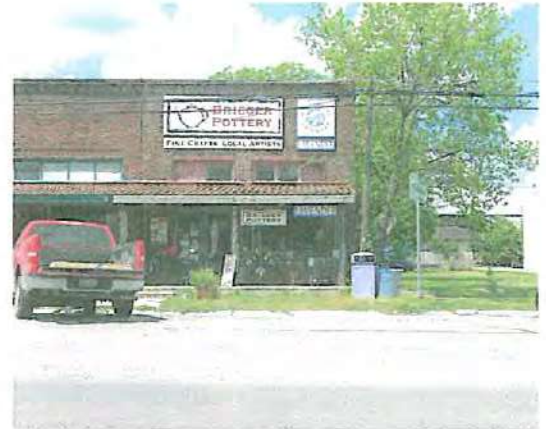
Boarded-up openings should be restored.

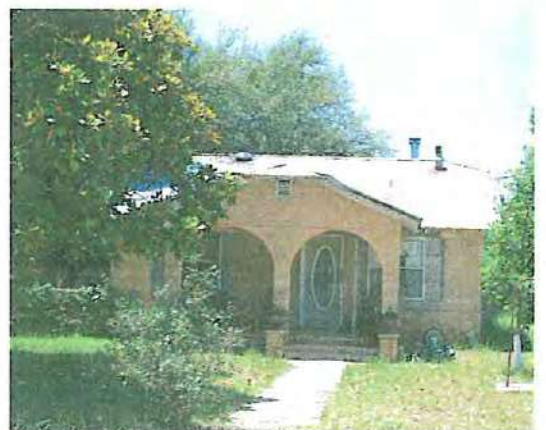
When replacement windows are not consistent with the original material and/or proportion, consideration should be given to replacing them to match the original.

- f. Evaluate the condition of the underlying historic material, replace in-kind with a dimension and profile to match original.
- g. When windows have been removed and replaced with windows of a different material and proportion, such as aluminum, consider replacing them with windows to match the original in material, proportion, configuration, and operation.

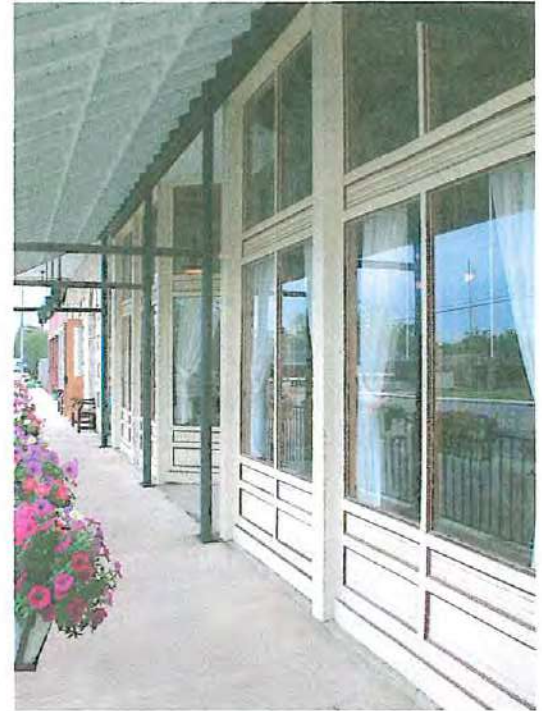
An example of three-part division storefront.

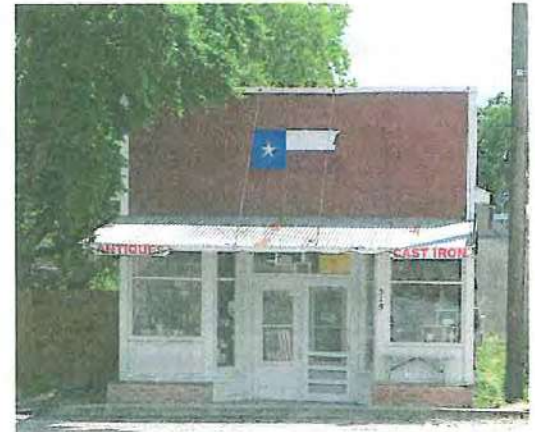
Three-part storefront with recessed entrance.

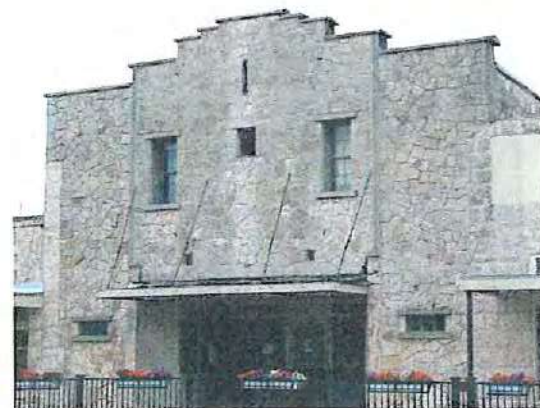
Example of canopies hung using rods.

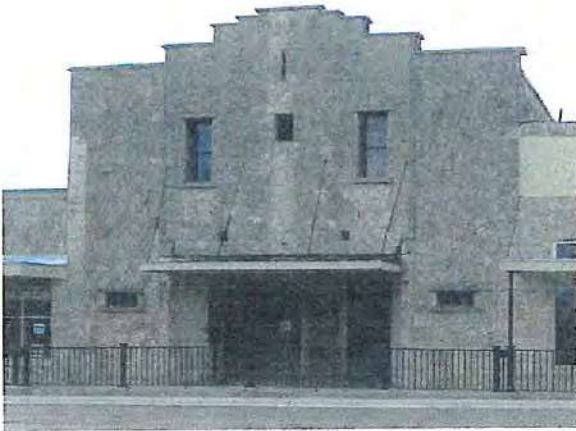
Example of tall, narrow windows that appear to be “punched” out, these should be maintained.

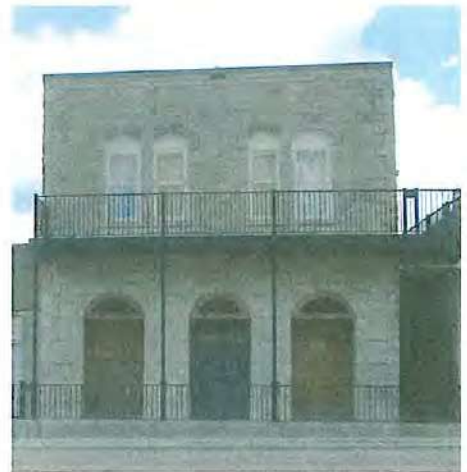
Replacing missing cornice and details is encouraged when enough evidence exists.

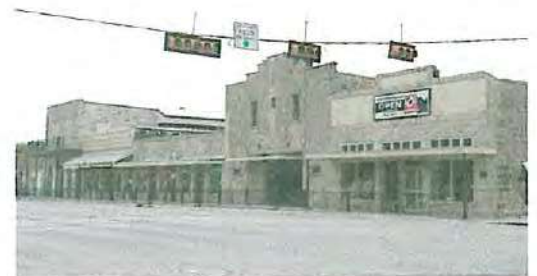
A common setback should be retained within the historic commercial district.

- a. This common line of construction shall be respected and maintained to give the appearance of a common wall.
- b. Construction shall not recede from this common setback and no part of the building shall project beyond this line except canopies, awnings, and signage.
- c. If the entrance to a building has been modified, consideration should be given to returning the entrance and wall of alignment back to its original position if future alterations are made.
- d. New construction should follow the historic building line.

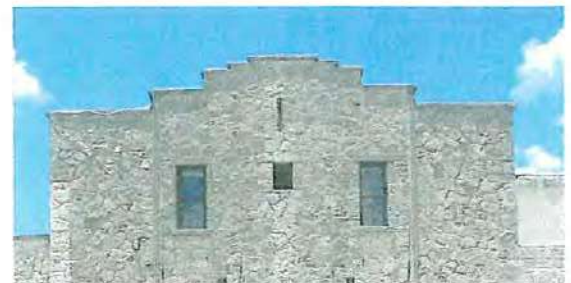
The private use of the upper floors is evident in the smaller expanse and size of windows.

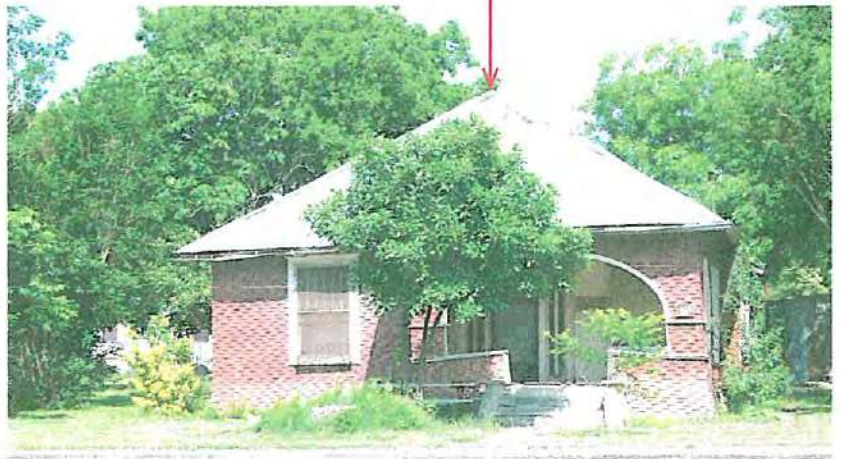
6.1.2. National Folk: Front Gable

- a. Front-facing gable
- b. Low-pitched roof
- c. Double-width form

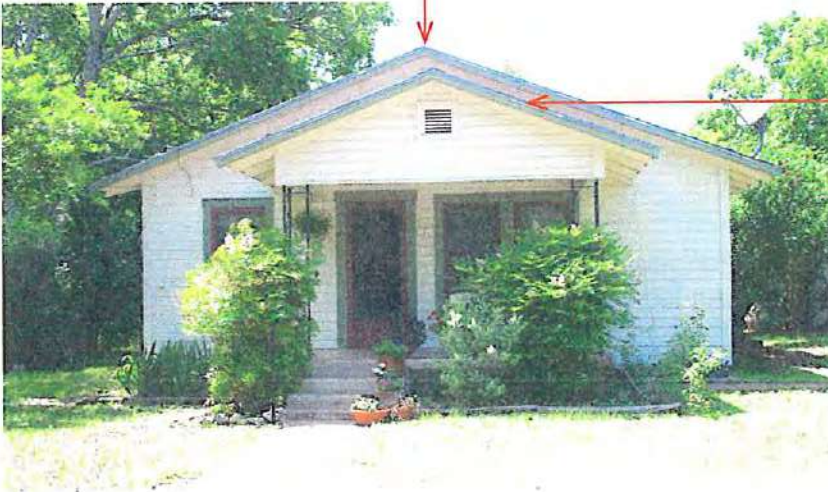
6.1.3. National Folk: Massed Plan, Side Gable

- a. Side-gabled roof
- b. Full-length shed roof porch
- c. Massed Plan
- d. One-story in height

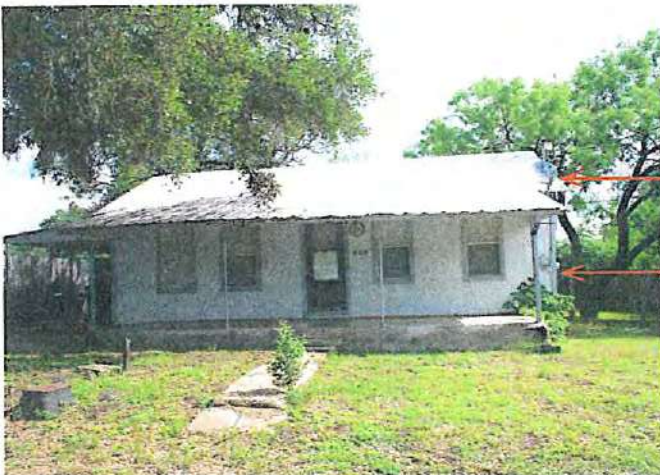
6.1.4. National Folk: Front Gable and Side Wing

- a. Side-gabled roof, with front-facing gabled wing
- b. Shed roof porch
- c. One-story in height
- d. Flexible interior spaces

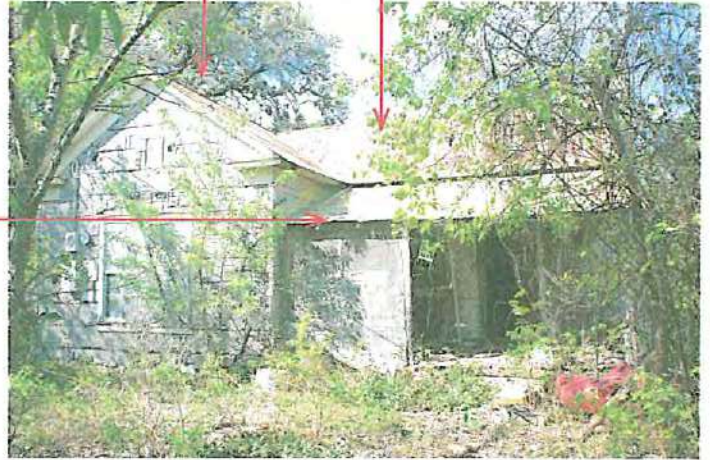
6.1.5. National Folk: Hall-and-Parlor

- a. Side-gabled roof
- b. Two rooms wide and one room deep
- c. Addition to rear
- d. Front porch

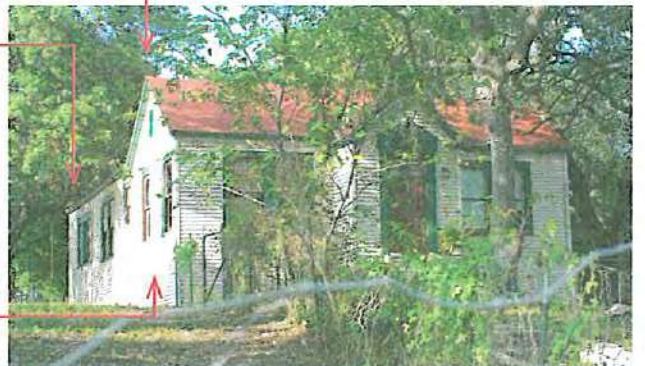
6.1.6. Greek Revival

- a. Entry porch with prominent columns
- b. Gabled or hip roof with a low pitch
- c. Emphasized cornice line with wide, divided trim

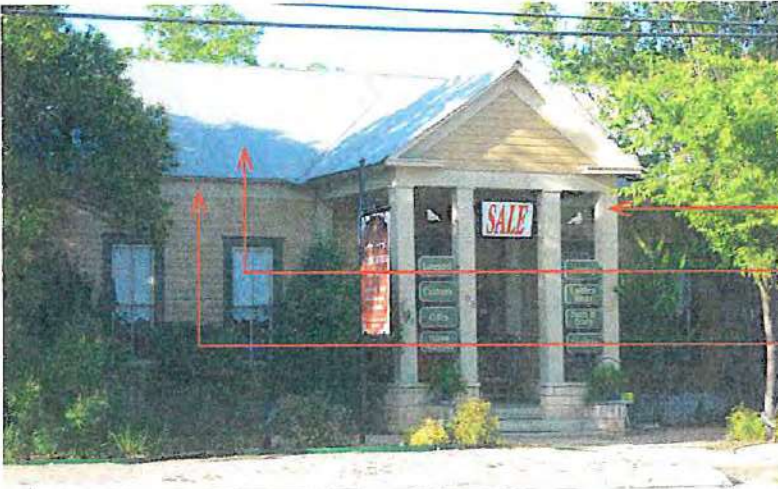
6.1.7. Queen Anne

- a. Asymmetrical facade
- b. Decorative wood detailing
- c. One story porch that extends along one or both side walls
- d. Steeply pitched, irregular shaped roof

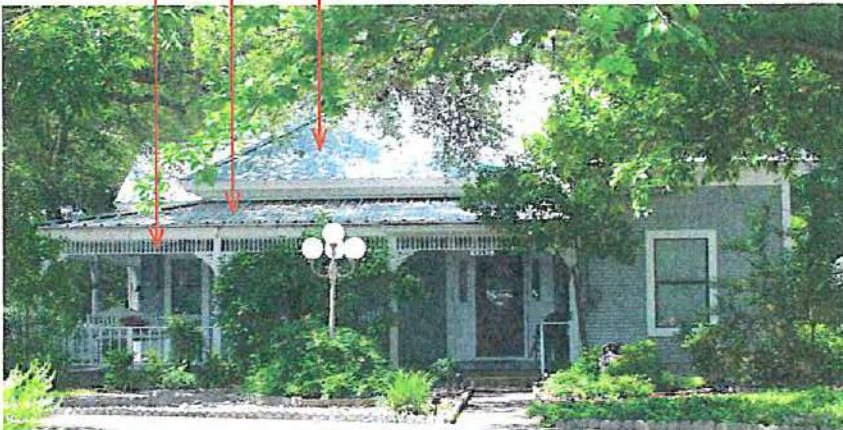
6.1.8. Folk Victorian

- a. Gabled roof
- b. Porch roof supports are either spindles or square posts
- c. Simple folk form
- d. Spindle work detailing

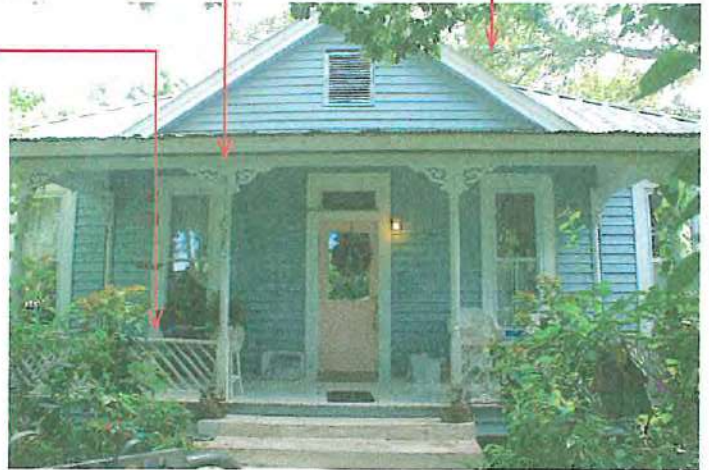
6.1.9. Craftsman

- a. Low-pitched gable roofs
- b. Porch roof supports are square or tapered columns
- c. Roof rafters and decorative beams are exposed
- d. Wide, open eave overhang

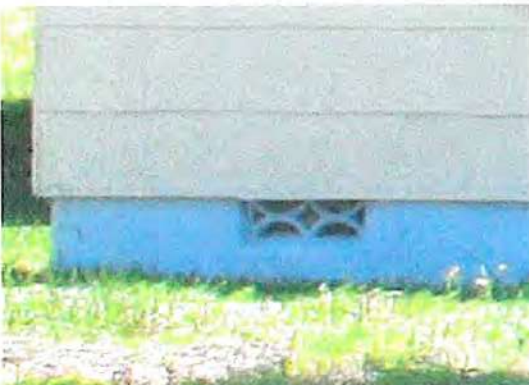
Vents along the perimeter provide necessary ventilation under the house.

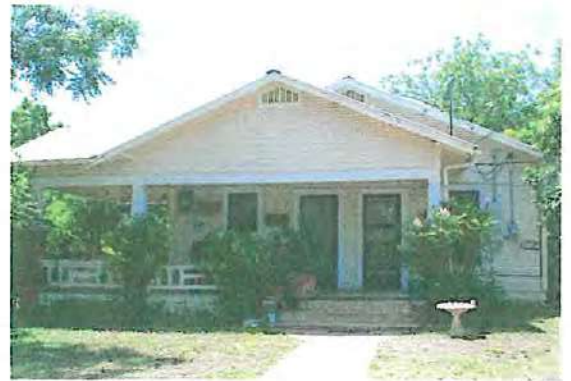
Elevated porches are typical of pier and beam residences.
